G-Wagen, W463, Water in Front Footwell Repair

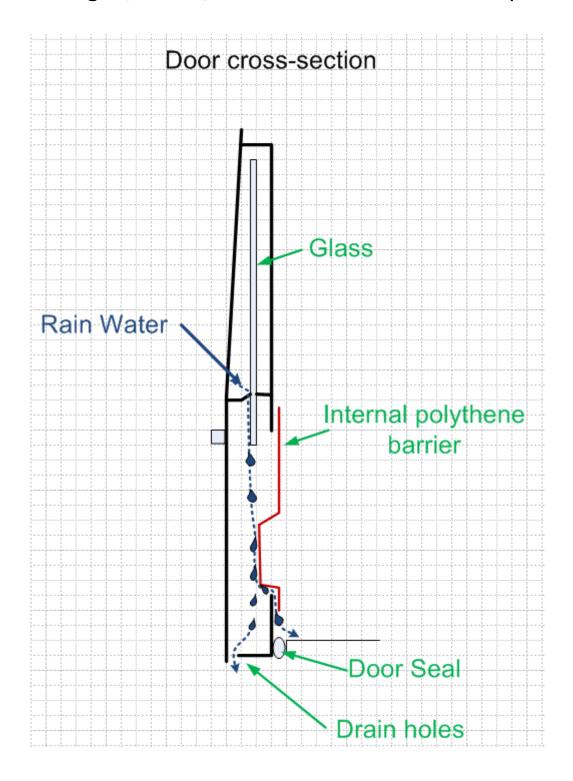
If the internal polythene sheet has become dis-attached from the door surround, water will enter the car
